WELD REPAIR HP TURBINE

HOUSTON LIGHTING & POWER CEDAR BAYOU #1

Reprinted from the
Presentation at
Joint Power Generation Conference

Thomas J. Stiebler
Houston Lighting & Power Company

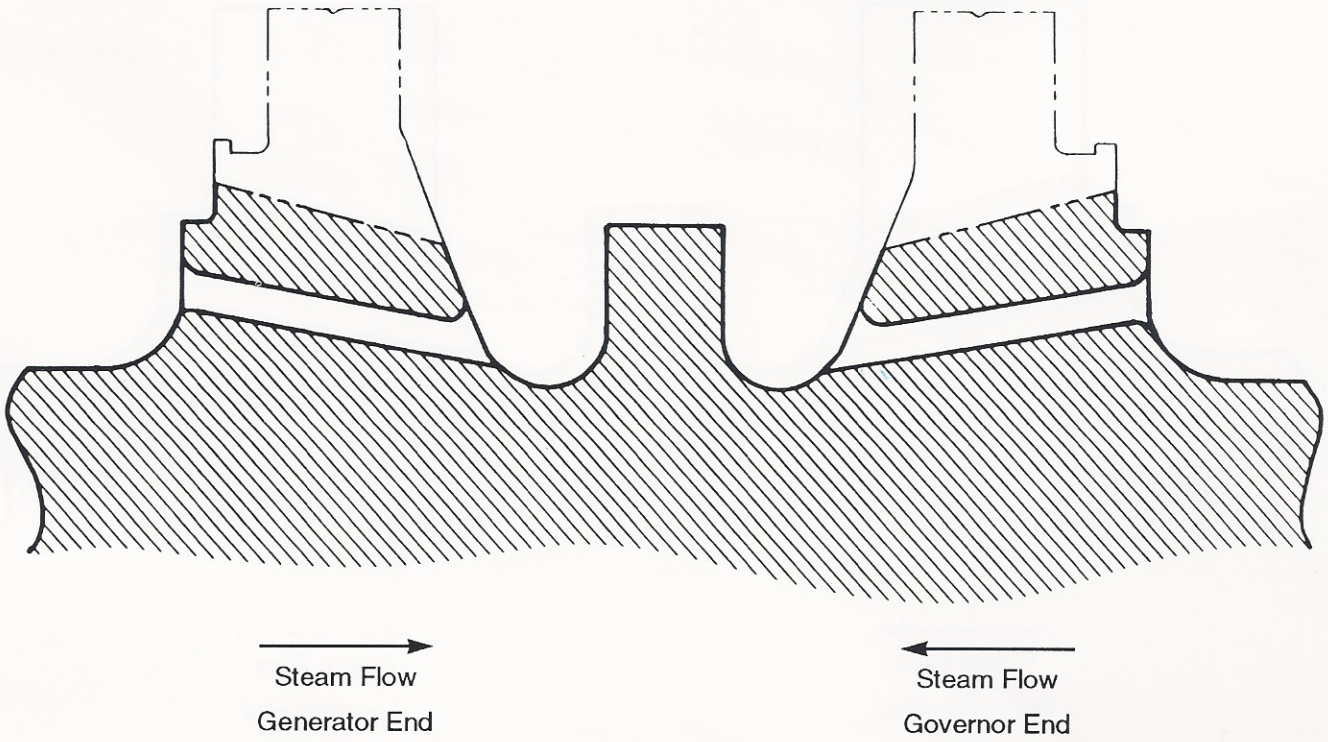
The "as-received" rotor was then placed in a lathe for final machine prior to welding (Figure #1). The blade roots were machined past the bottom of the root to the point of least stress on that area of the rotor. Most weld failures occur in the heat-affected zone, so it was prudent to put the heat-affected zone in the lowest-stressed area. The machined surface was then tested with UT and MT inspection with no recordable indications being found.

Figure 1. Original Blades and Roots Machined Off

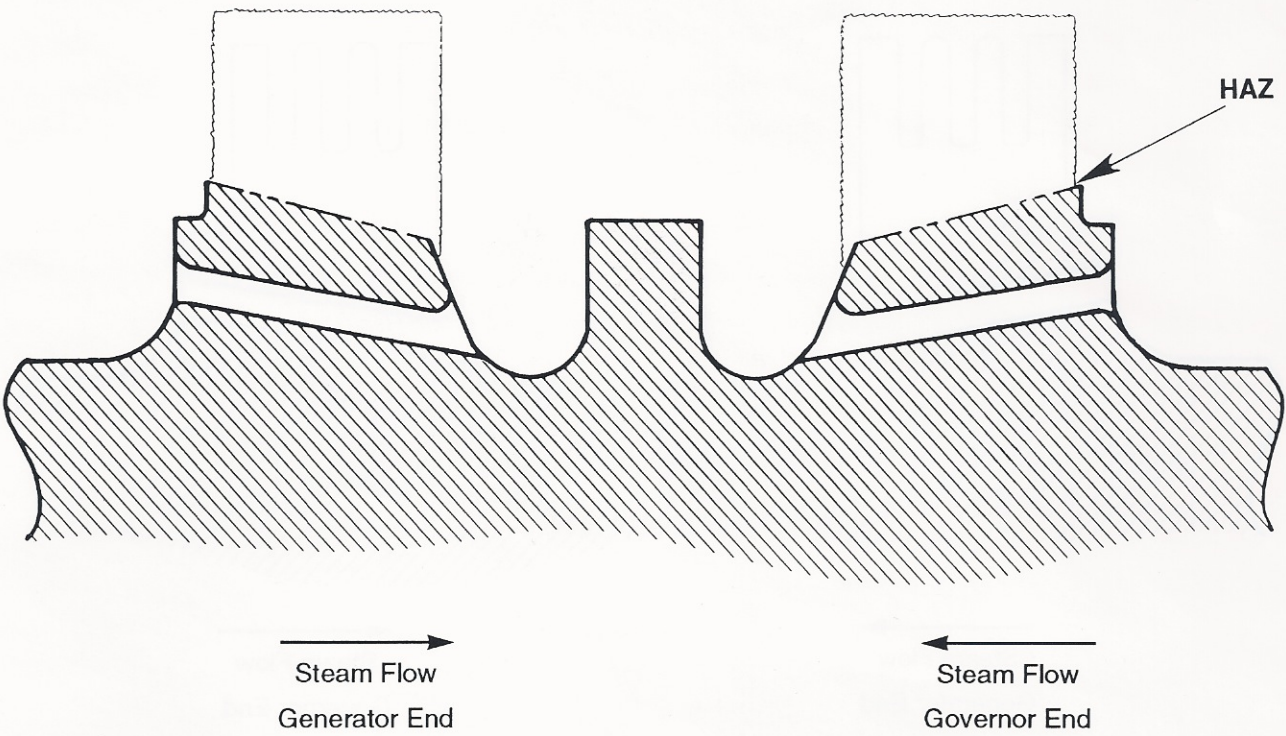
Figure 2. Welded Area

The welding was completed in two steps. The first eight layers were completed with one process and the remaining 78 layers with a second process. Both processes use GTAW. The first process, called "the Overlay," is performed at extremely low amperage and is undulated. The pass size is small (20 passes per layer). The second pass is called the "build-up." The amperage is high and weld bead is larger (14 passes per layer). There were 1,321 total passes on the governor and 1,361 total passes on the generator end. Both processes used the same gases with some change in percentages and pressure. The gas used was extremely clean and presented no problems during welding. Temperatures were constantly recorded and the tungsten tips were replaced periodically to avoid tungsten contamination. There were no tungsten problems either. The welding was uneventful except for two incidents which created some confusion and slowed the repair process, but did not affect the integrity of the repair. One incident occurred when a

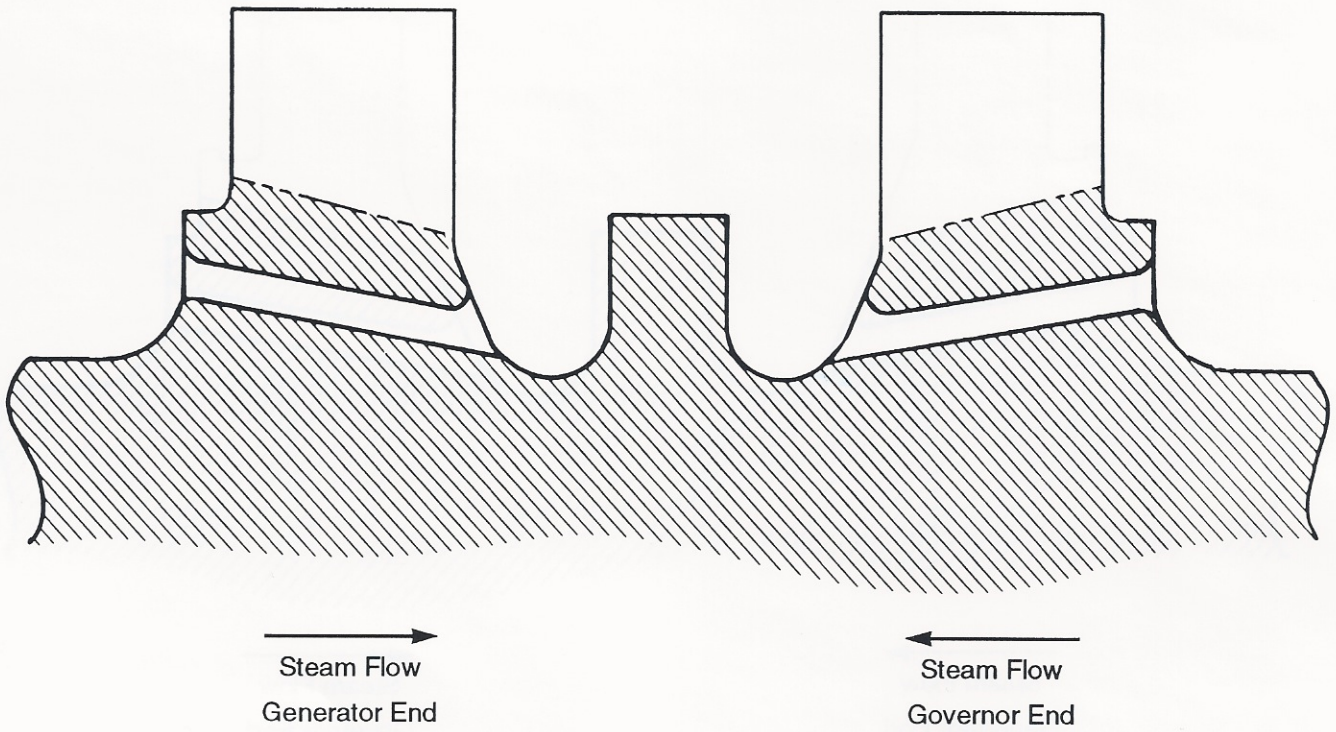
The next process completed after welding and cool-down was the rough machining of welded areas (Figure #1). The weld material was machined to the rough dimensions without incident. In fact, the only problems with **any** machining was “normal tool breakage.” Both control stages (governor end, generator end) were rough-machined, then polished for NDE.

Figure 3. Rough Machine After Welding

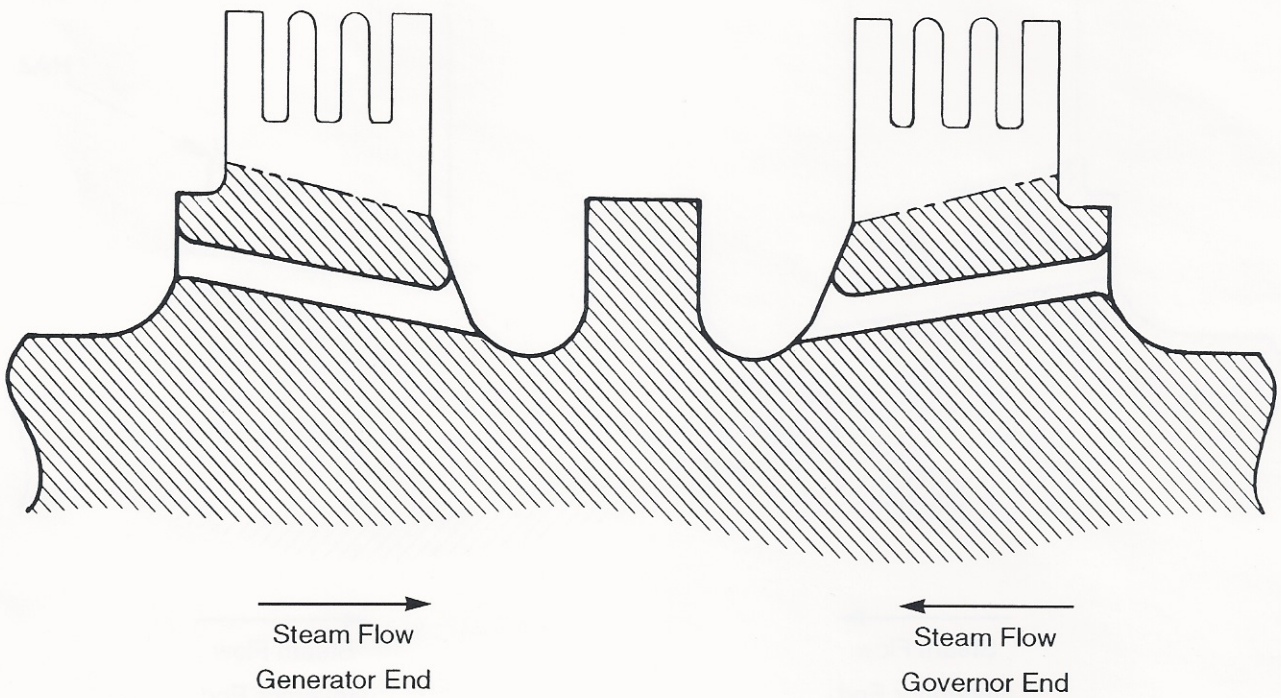
Completion of the NDE and clearance to proceed allowed the next process to begin. Final machining of the “fingers” in the rotor was completed without incident (Figure #4). Nothing was special about machining the weldment. The weld material appeared to machine easily.

Figure 4. Machine Fingers

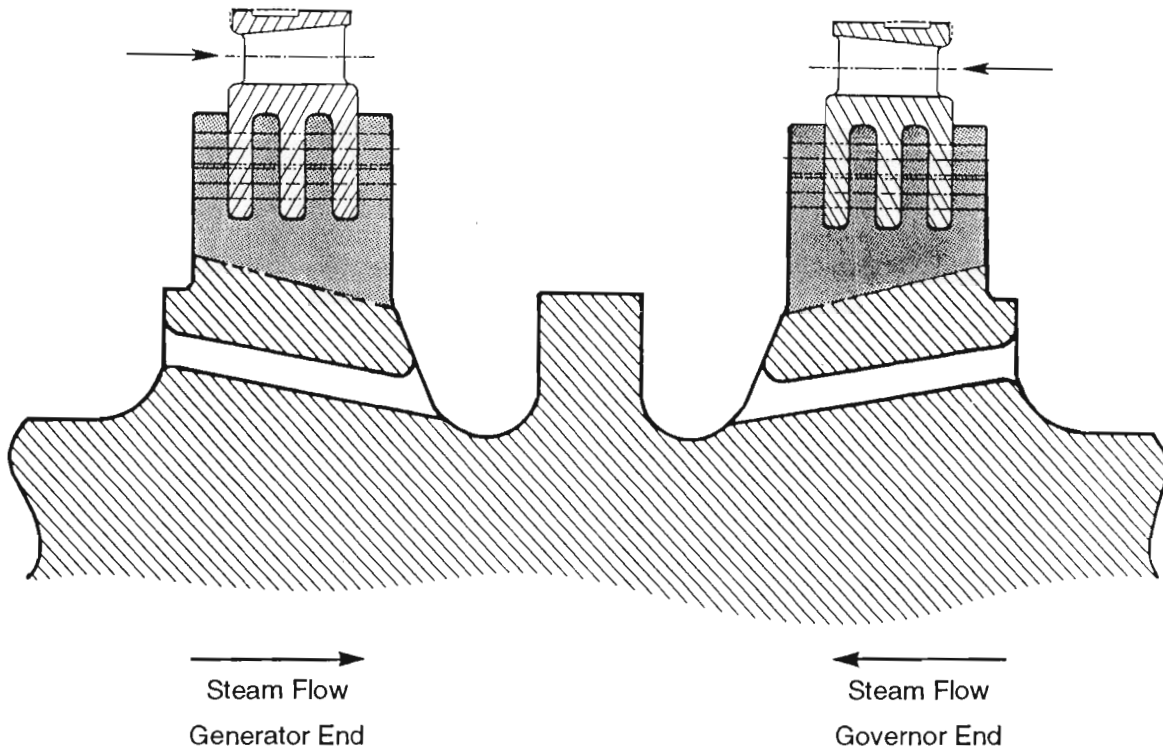
The next major task was installation of the new Triple Pin Blades (Figure #5). The blades are in groups of three and machined from one “block.” There were 90 blades and 30 blade groups. There are three pins per blade group. All the

Figure 5. Installation of the new Triple-Pin Blades
